RESEARCH MEMORANDUM

FLIGHT MEASUREMENTS OF THE LONGITUDINAL STABILITY AND CONTROL

CHARACTERISTICS OF THE GRUMMAN F8F-1 AIRPLANE --

TED NO. NACA 2379

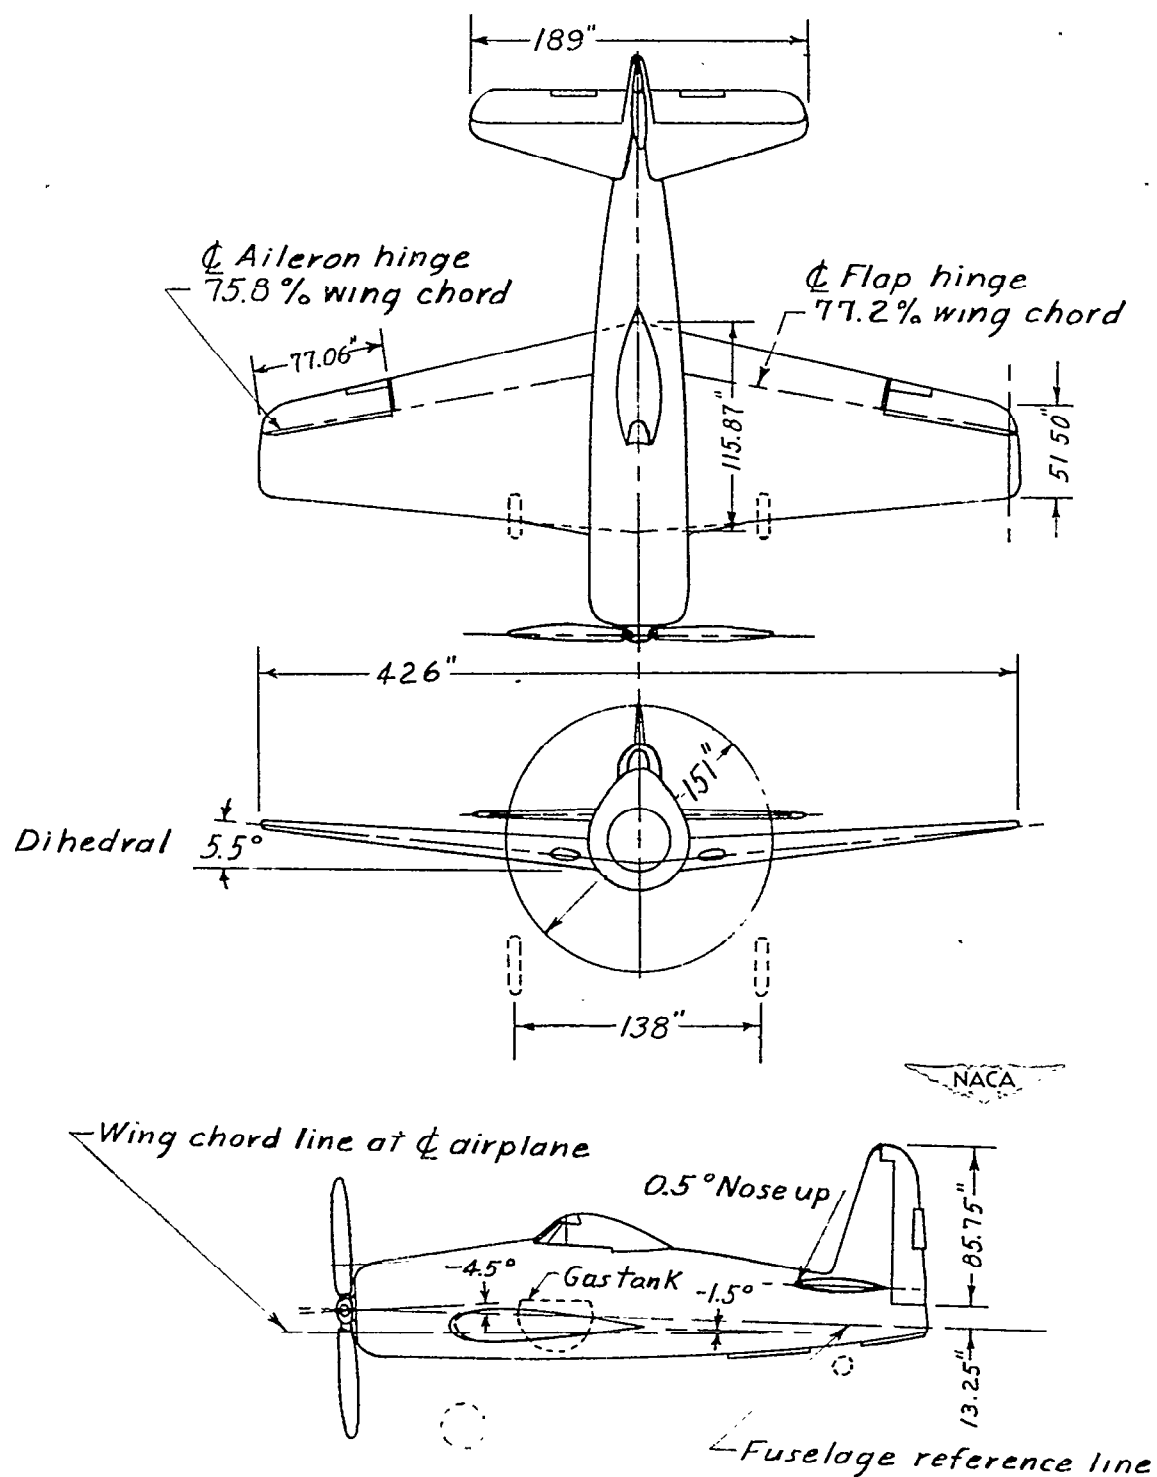
Figure 1.- Three-view drawing of the Grumman F8F-1 airplane.

The Grumman F8F-1, number 94873, used in this investigation was a production airplane with a modified vertical tail (configuration 3 of reference 1). A three-view drawing of the airplane is presented in figure 1. The airplane was constructed of metal except for the control surfaces, which were covered with fabric. Trimming tabs were provided on the rudder, both elevator surfaces, and the left aileron. All the control surfaces were aerodynamically balanced, the elevator having the overhanging type, the rudder a horn type, and the ailerons the Frise type balance. In addition, both ailerons had spring tabs, and a bob-weight was installed in the elevator control system which required a pull force on the control stick of approximately 5 pounds per g. Cross sections of the control surfaces are shown in figure 2. The variation of elevator position with deflection of the control stick is presented in figure 3. Elevator deflections were measured with respect to the stabilizer, the incidence of which was 0.5° , leading edge up from the fuselage reference line. The airplane was designed to incorporate a belly tank, but all the tests reported herein were made with the belly tank off. General specifications of the airplane are given in table I. A more complete description and photographs of the airplane are presented in reference 1.

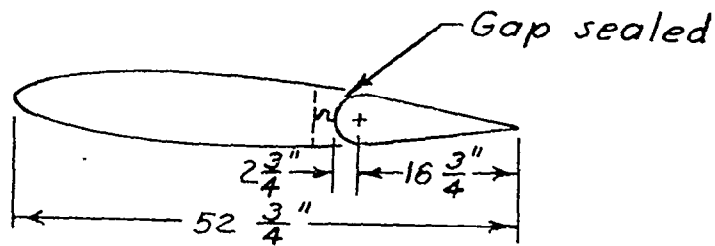
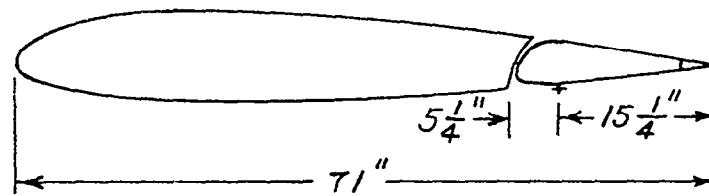
Vertical tail, 21 inches above fuselage reference line

Horizontal tail, 15 inches from center line

Wing and aileron, near inboard end of aileron

Figure 2.- Section views through the aerodynamic surfaces of the Grumman F8F-1 airplane.

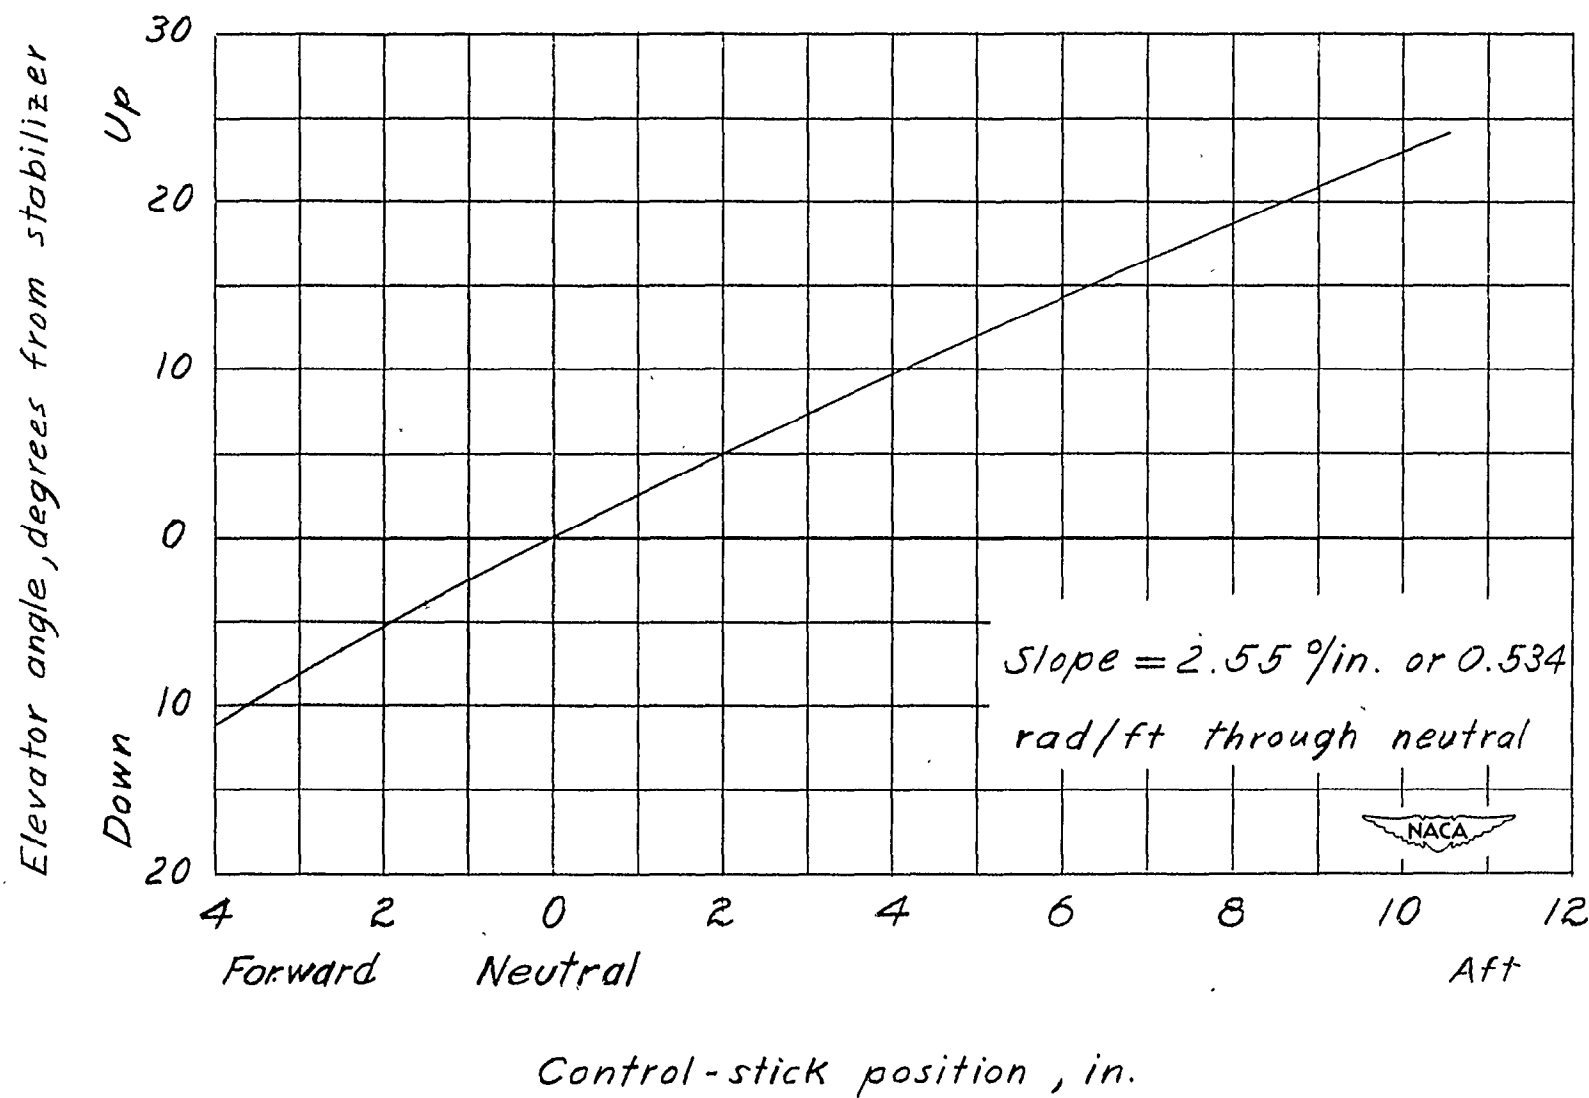
Figure 3.- Linkage between the control stick and elevator of the Grumman F8F-1 airplane.

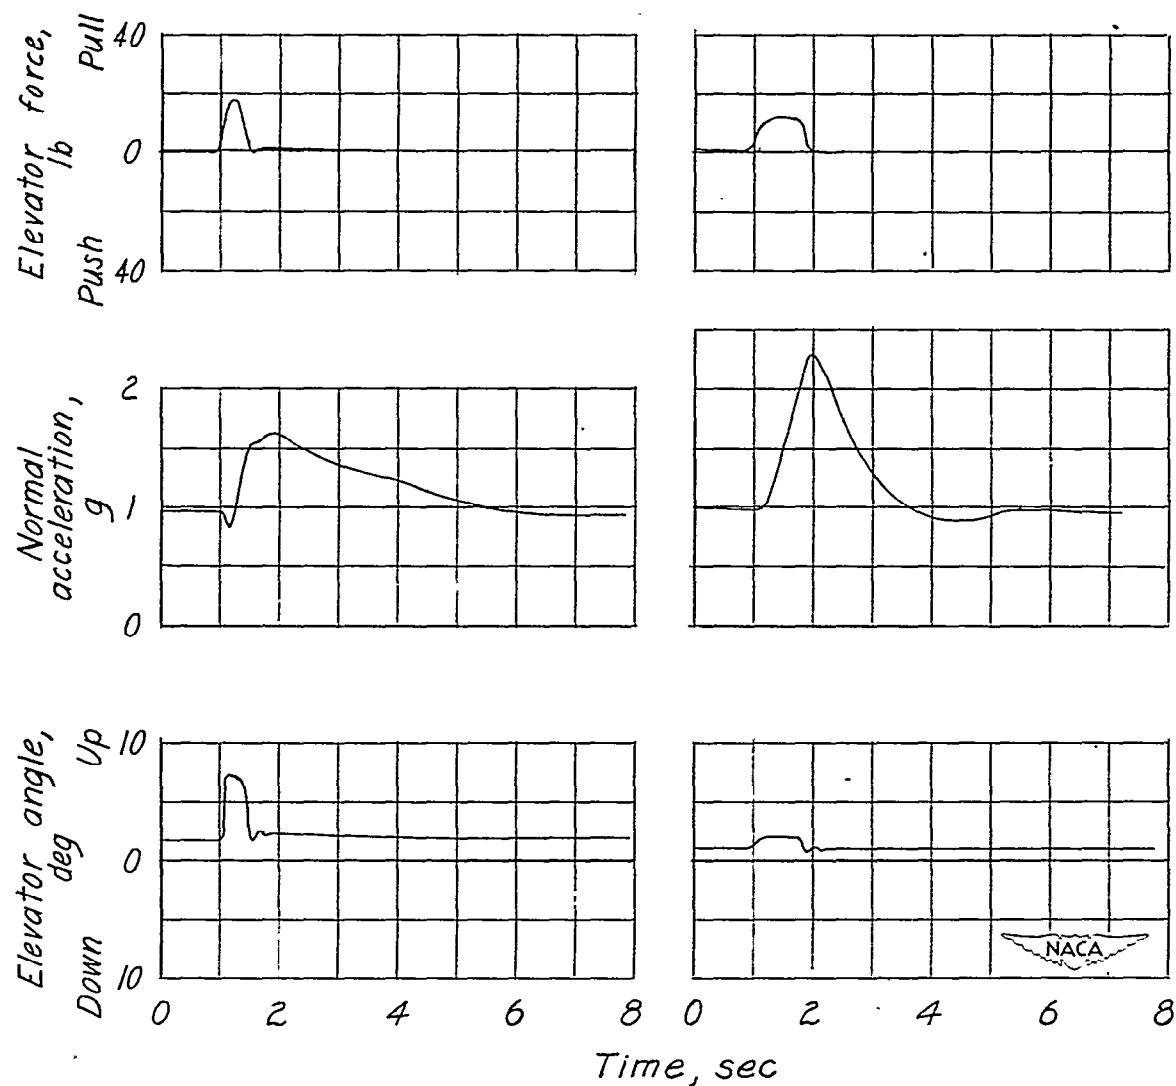
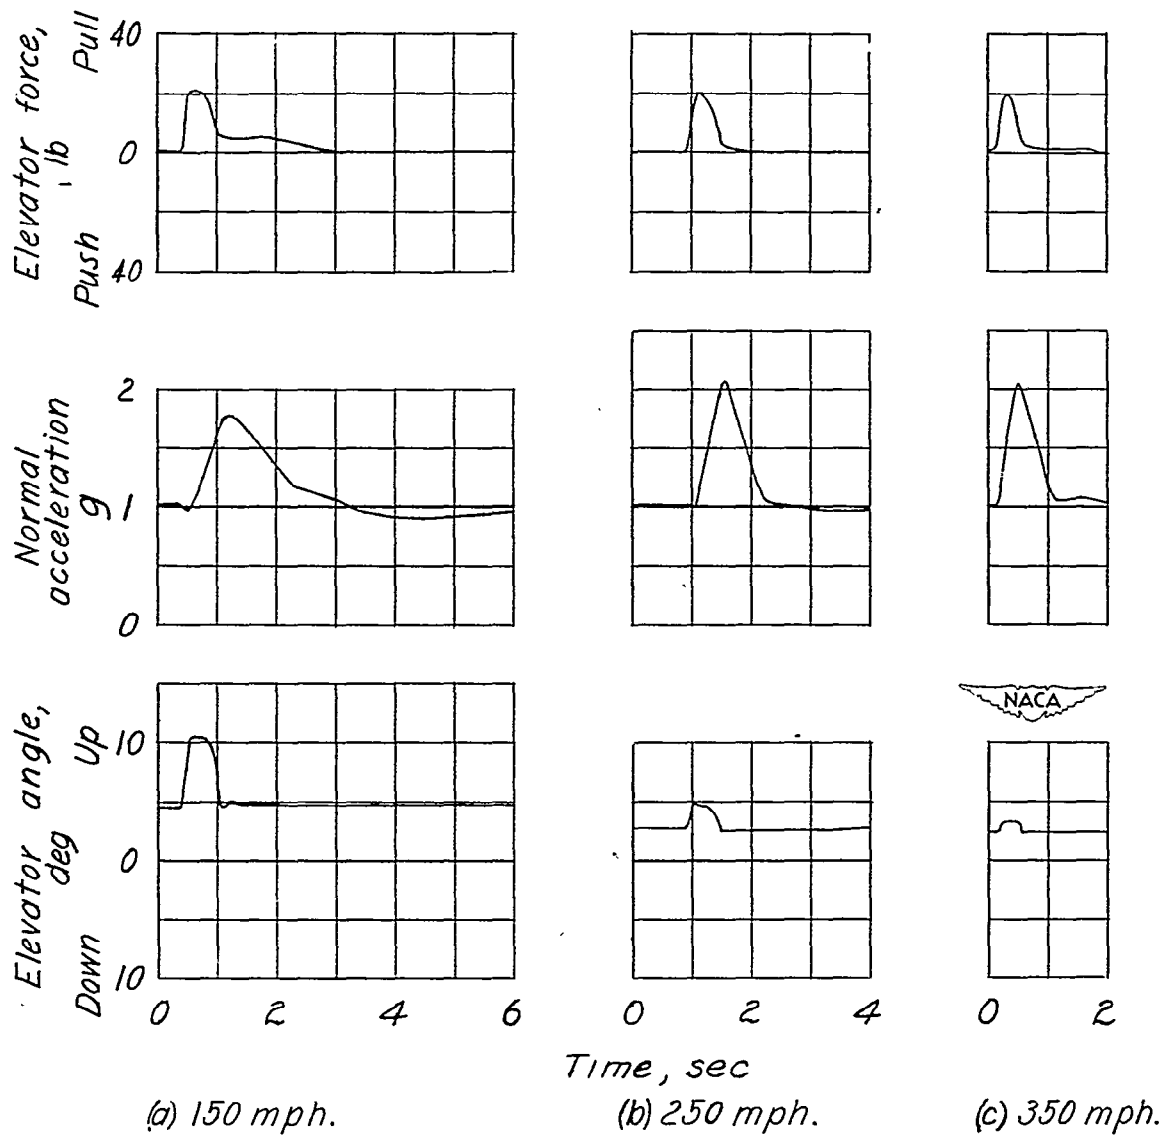
(a) 150 mph.

(b) 250 mph.

(a) Center of gravity at 25.2 percent mean aerodynamic chord.

Figure 4.- Short-period longitudinal oscillations in the rated-power clean condition, Grumman F8F-1.

(c) Center of gravity at 20.7 percent mean aerodynamic chord.

Short-period oscillations were induced in the rated-power clean condition at several speeds for each of two center-of-gravity positions at an altitude of approximately 10,000 feet. The procedure used was to trim the airplane, then abruptly pull up to approximately 2g and release the control column. Time histories of these pull-ups are presented in figure 4. Very small oscillations of the elevator occurred in some cases, particularly at low speeds, but were satisfactorily damped. The period of the elevator oscillation was short enough so that the airplane did not respond, as shown by the records of normal acceleration. No unusual rough-air effects on longitudinal stability were noted by the pilot.

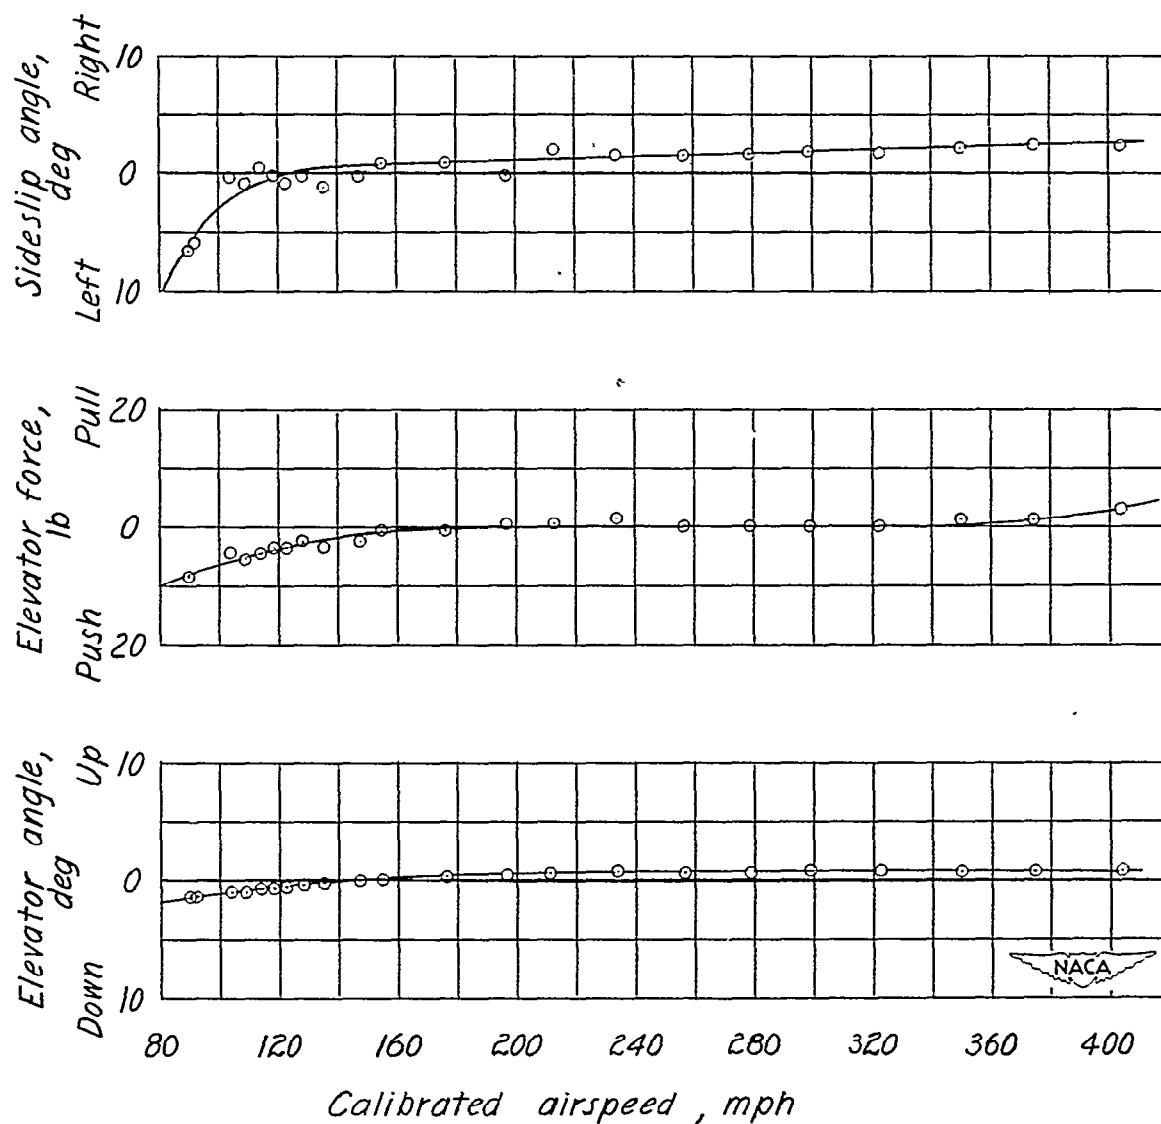
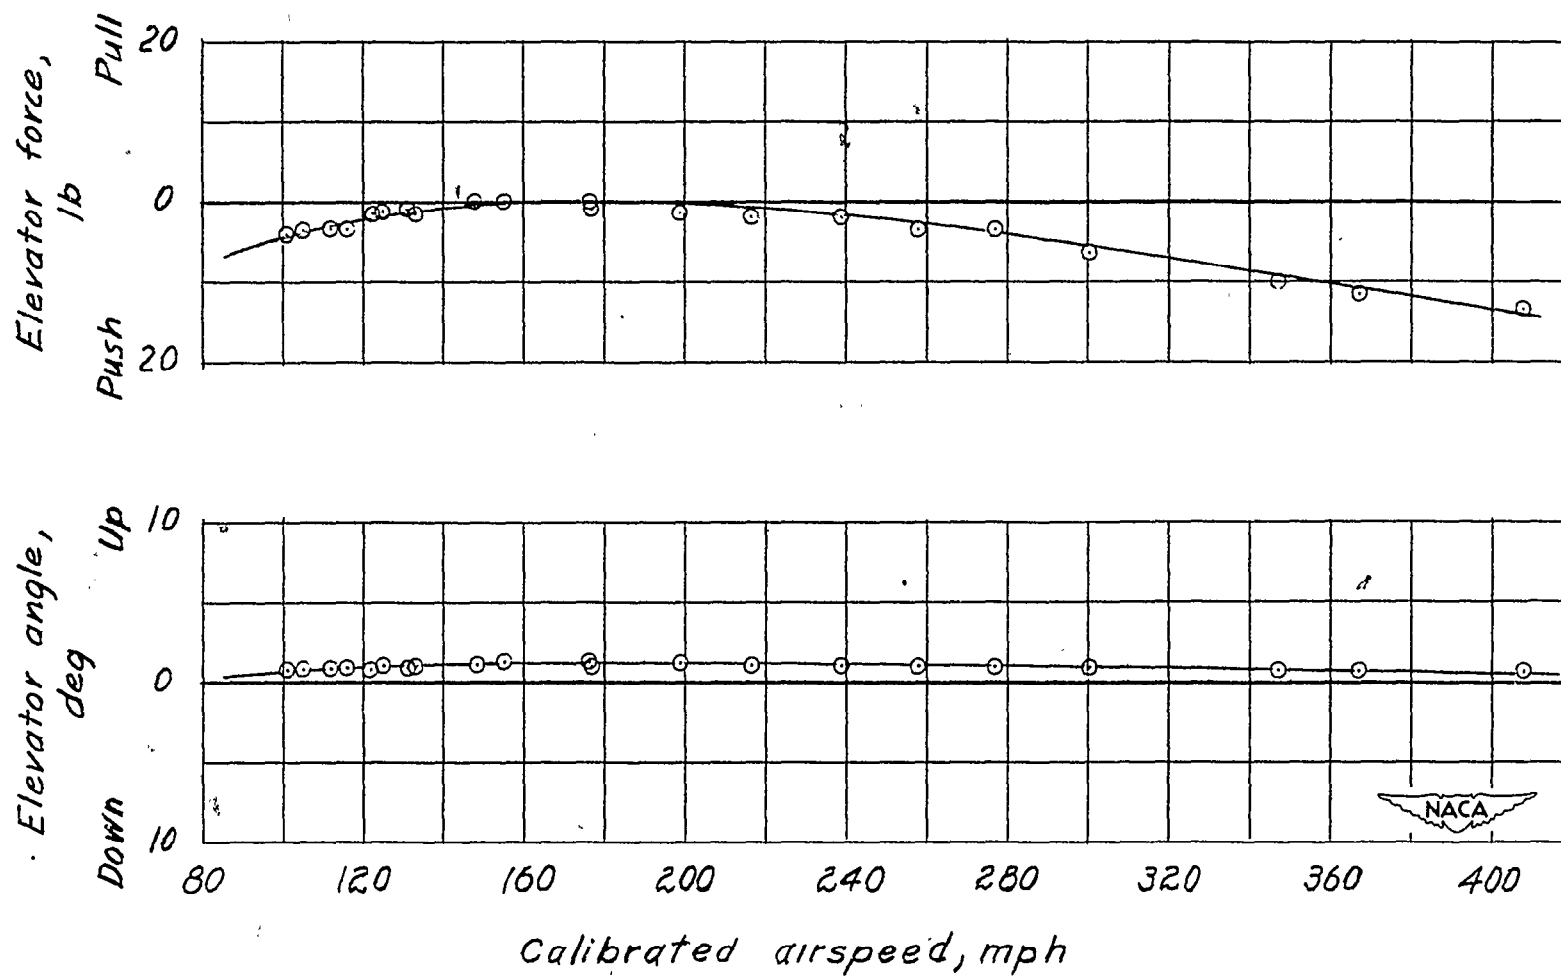
(a) Center of gravity at 27.1 percent mean aerodynamic chord and elevator trimming tabs set at neutral.

Figure 5.- Static longitudinal stability characteristics of the Grumman F8F-1 in the rated-power clean condition. Flaps up; landing gear up; 38 in. of Hg at 2600 rpm; oil cooler closed; cowl flaps, 3/4 in. open; 5000 to 12,000 feet.

(b) Center of gravity at 22.1 percent mean aerodynamic chord and elevator trimming tabs set at 2° nose down.

Figures 5 to 7 contain plots of the variation of elevator angle, elevator control force, and sideslip angle in straight flight against calibrated airspeed. For this series of tests, the pilot held the airplane at essentially zero angle of bank and, therefore, laterally level flight can be assumed. Plots of the variation of the elevator angle with normal-force coefficient and the variation of elevator force divided by the impact pressure F_e/q_c with normal-force coefficient are presented in figure 8 for the three conditions tested. The stick-fixed and stick-free neutral points were determined from the slopes of these curves. The neutral points for a given lift coefficient are defined as the center-of-gravity positions at which the slopes $\frac{d\delta_e}{dC_N}$ and $\frac{dF_e/q_c}{dC_N}$ are zero. The determination of the neutral points in the rated-power clean, gliding, and power-approach conditions for several normal-force coefficients is shown in figure 9. Figure 10 shows the variation of stick-fixed and stick-free neutral points with normal-force coefficient.

1. Rated-power clean condition. - The airplane was unstable up to approximately 220 miles per hour and neutrally stable from 220 to 400 miles per hour, stick fixed, and unstable up to approximately 180 miles per hour and neutrally stable from 180 to 340 miles per hour, stick free, for the aft center-of-gravity position (27.1 percent M.A.C.) when trimmed for laterally level straight flight at 180 miles per hour. For the forward center-of-gravity position (22.1 percent M.A.C.), the airplane was unstable below the trim speed and stable above, stick fixed and stick free.

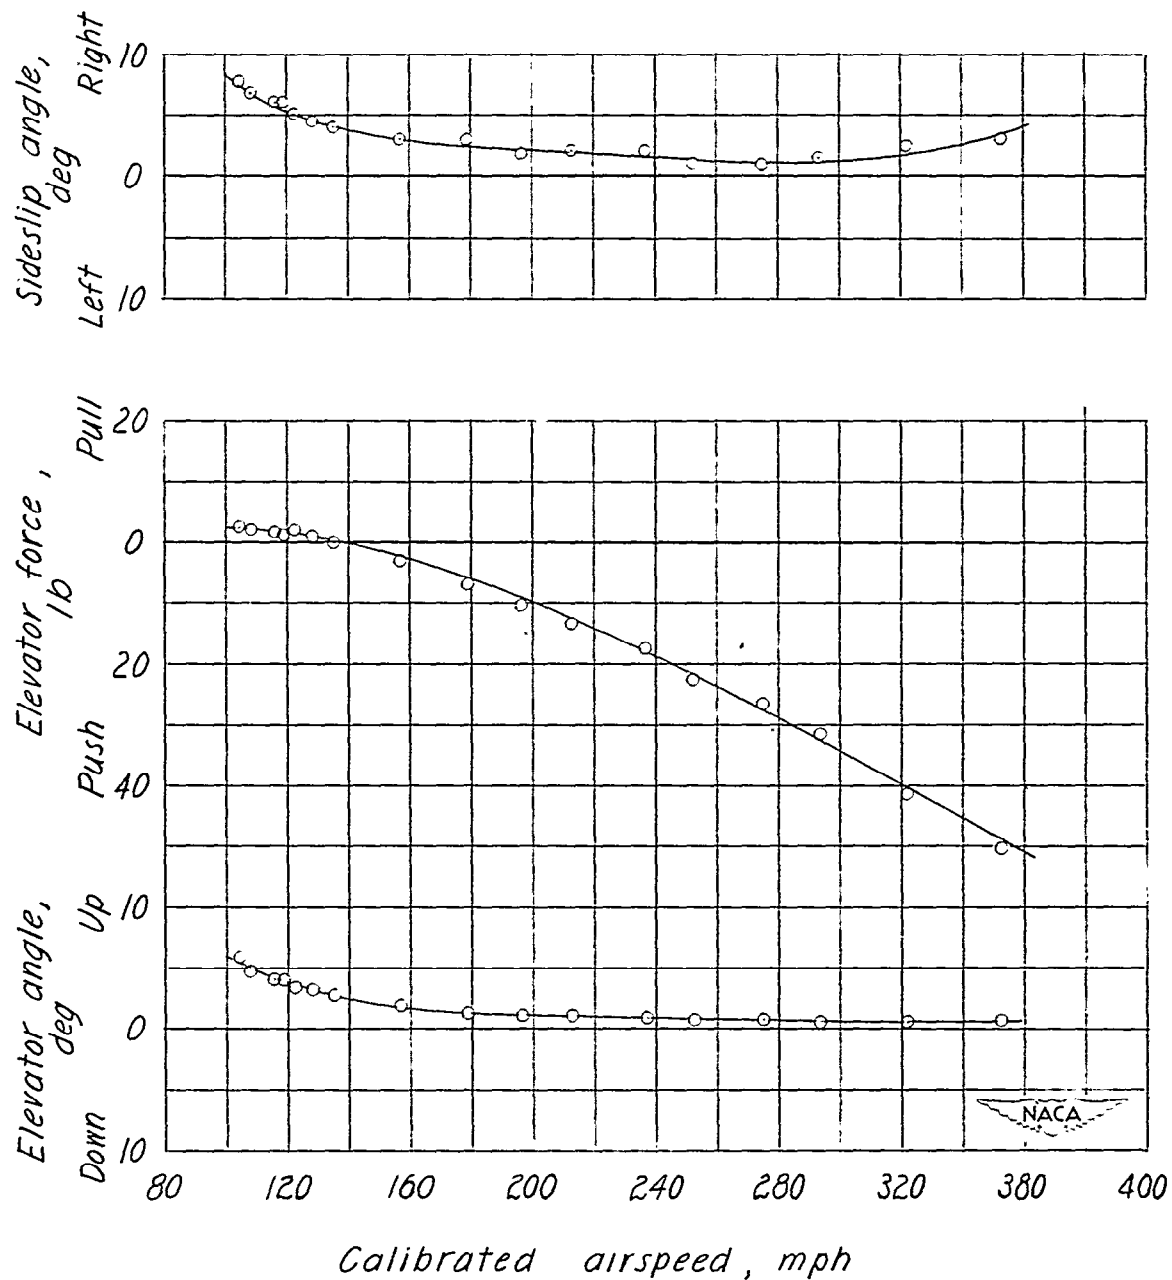
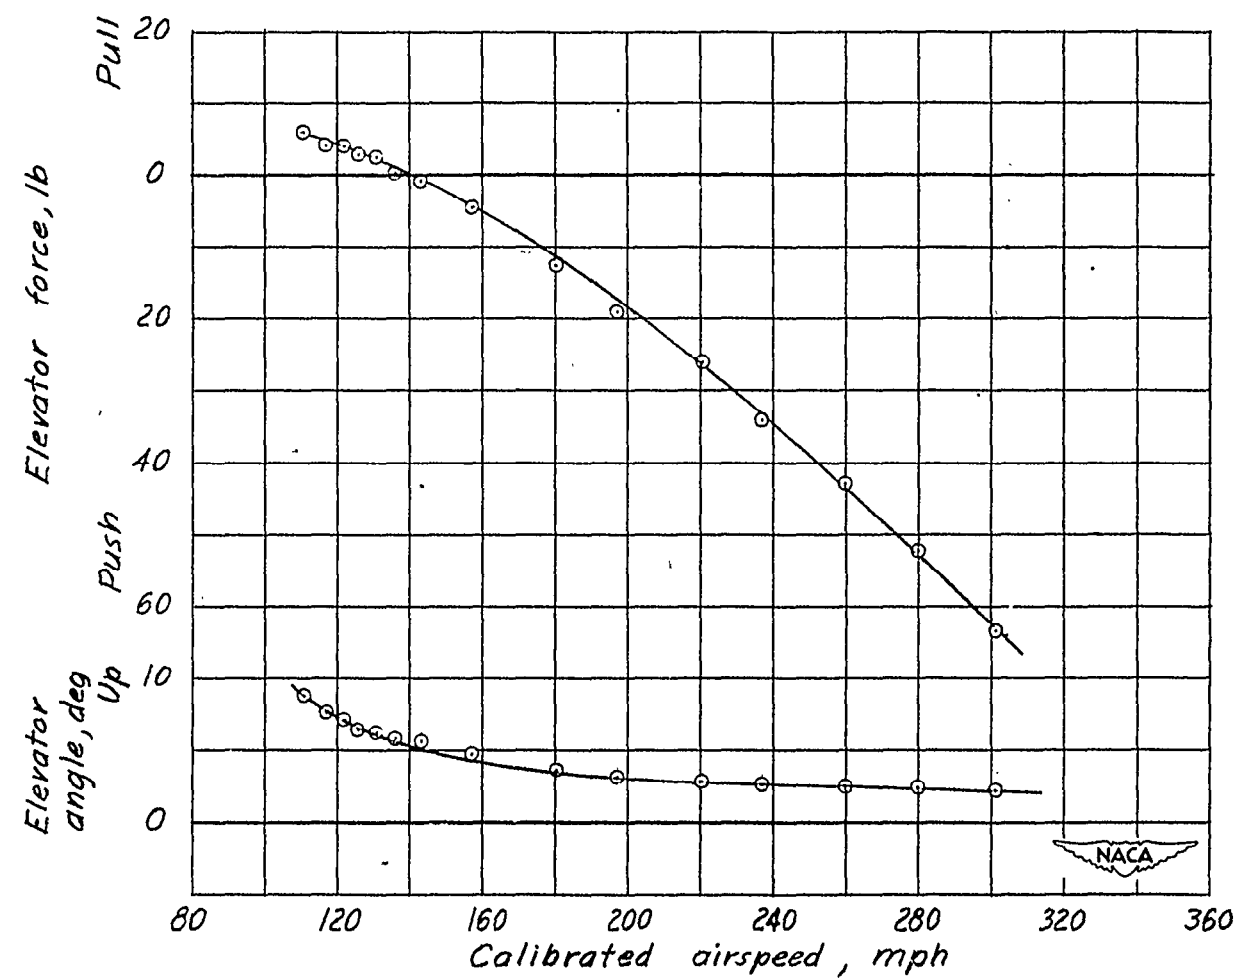
(a) Center of gravity at 25.7 percent mean aerodynamic chord and elevator trimming tabs set at 4.5° nose up.

Figure 6.- Static longitudinal stability characteristics of the Grumman F8F-1 airplane in the gliding condition. Flaps up; landing gear up; engine idling.

(b) Center of gravity at 22.2 percent mean aerodynamic chord and elevator trimming tabs set at 9° nose up.

2. Gliding condition. - The airplane was stable, stick fixed and stick free, for the aft center-of-gravity position (25.7 percent M.A.C.) and the forward center-of-gravity position (22.2 percent M.A.C.) when trimmed for laterally level straight flight at 140 miles per hour.

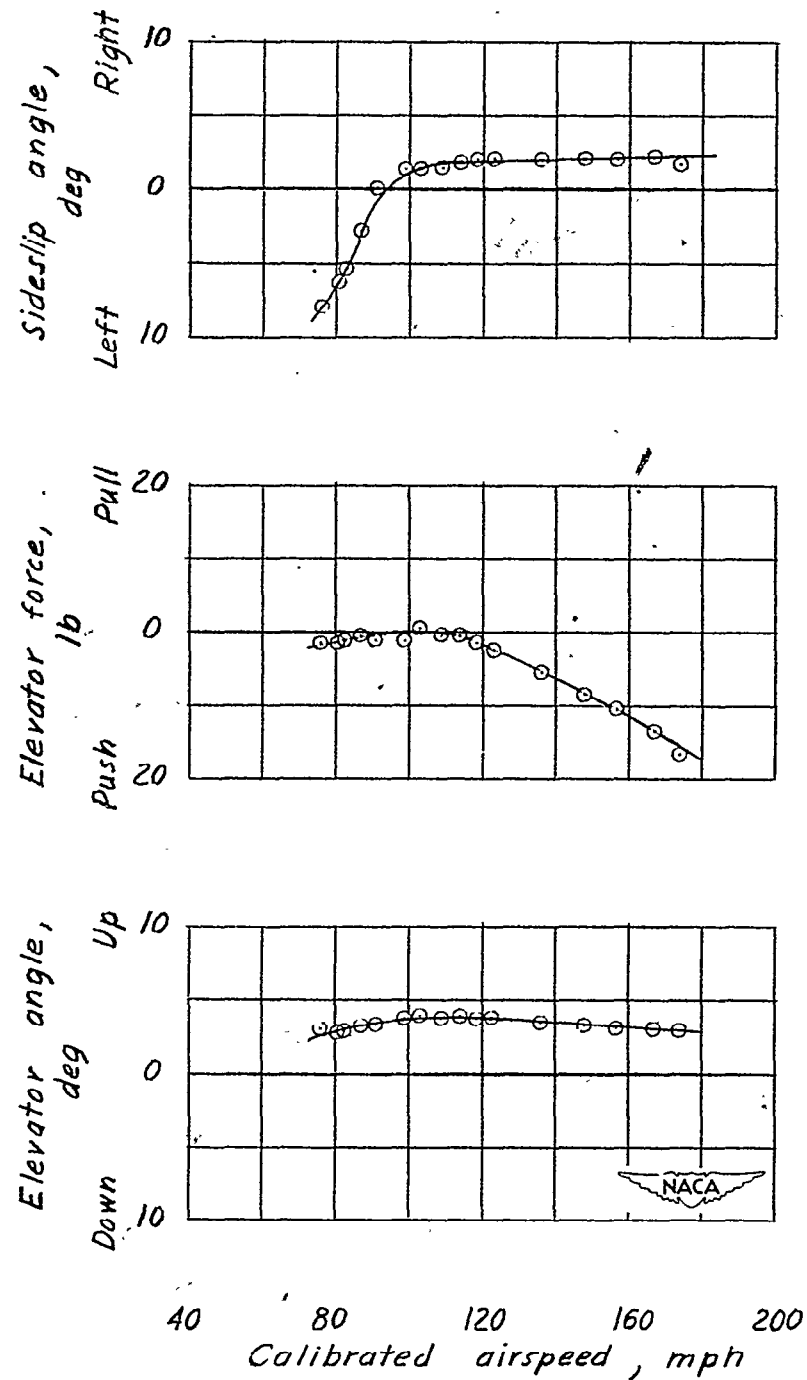
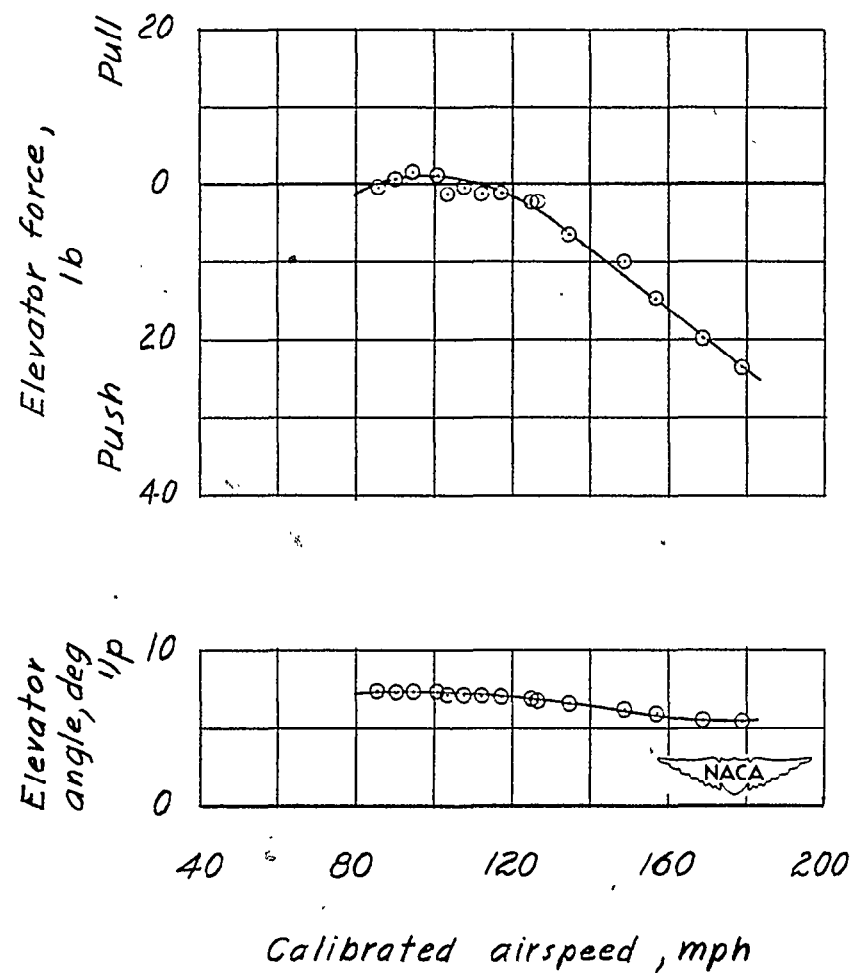
(a) Center of gravity at 24.8 percent mean aerodynamic chord and elevator trimming tabs set at 11.2° nose up.

Figure 7.- Static longitudinal stability characteristics of the Grumman F8F-1 airplane in the power-approach condition. Flaps down; landing gear down; 20 in. of Hg at 2300 rpm.

(b) Center of gravity at 21.2 mean aerodynamic chord and elevator trimming tabs set at full nose up (not trim).

3. Power-approach condition. - The airplane was unstable below the trim speed of 110 miles per hour and stable above, stick fixed and stick free, for the aft center-of-gravity position (24.8 percent M.A.C.). For the forward center-of-gravity position (21.2 percent M.A.C.) the airplane was unstable below 100 miles per hour and stable above, stick fixed and stick free.

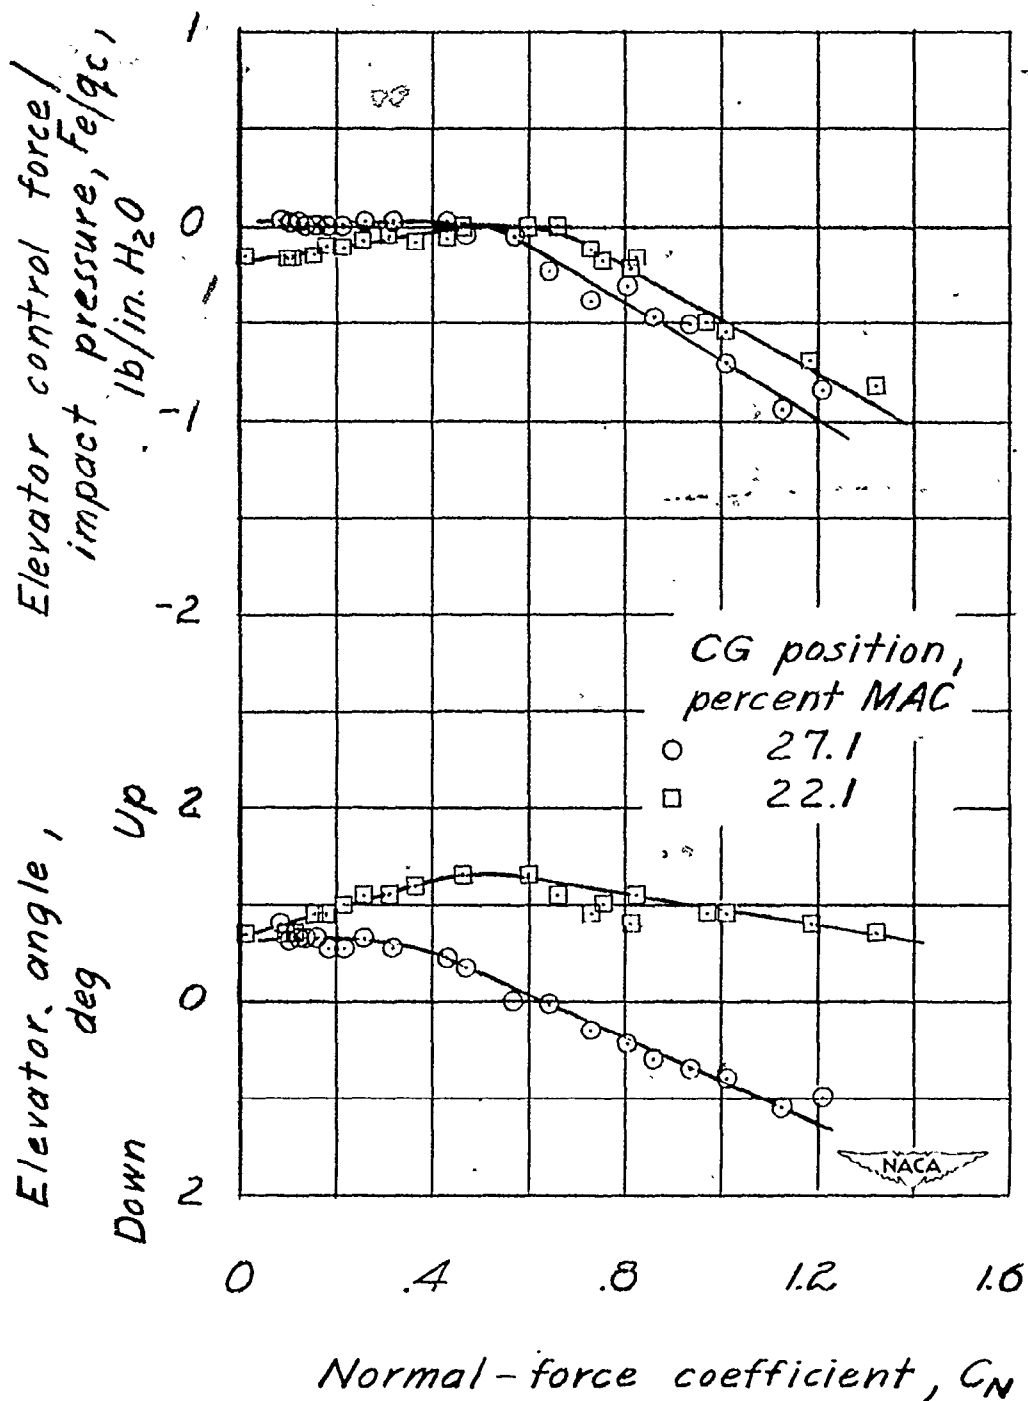
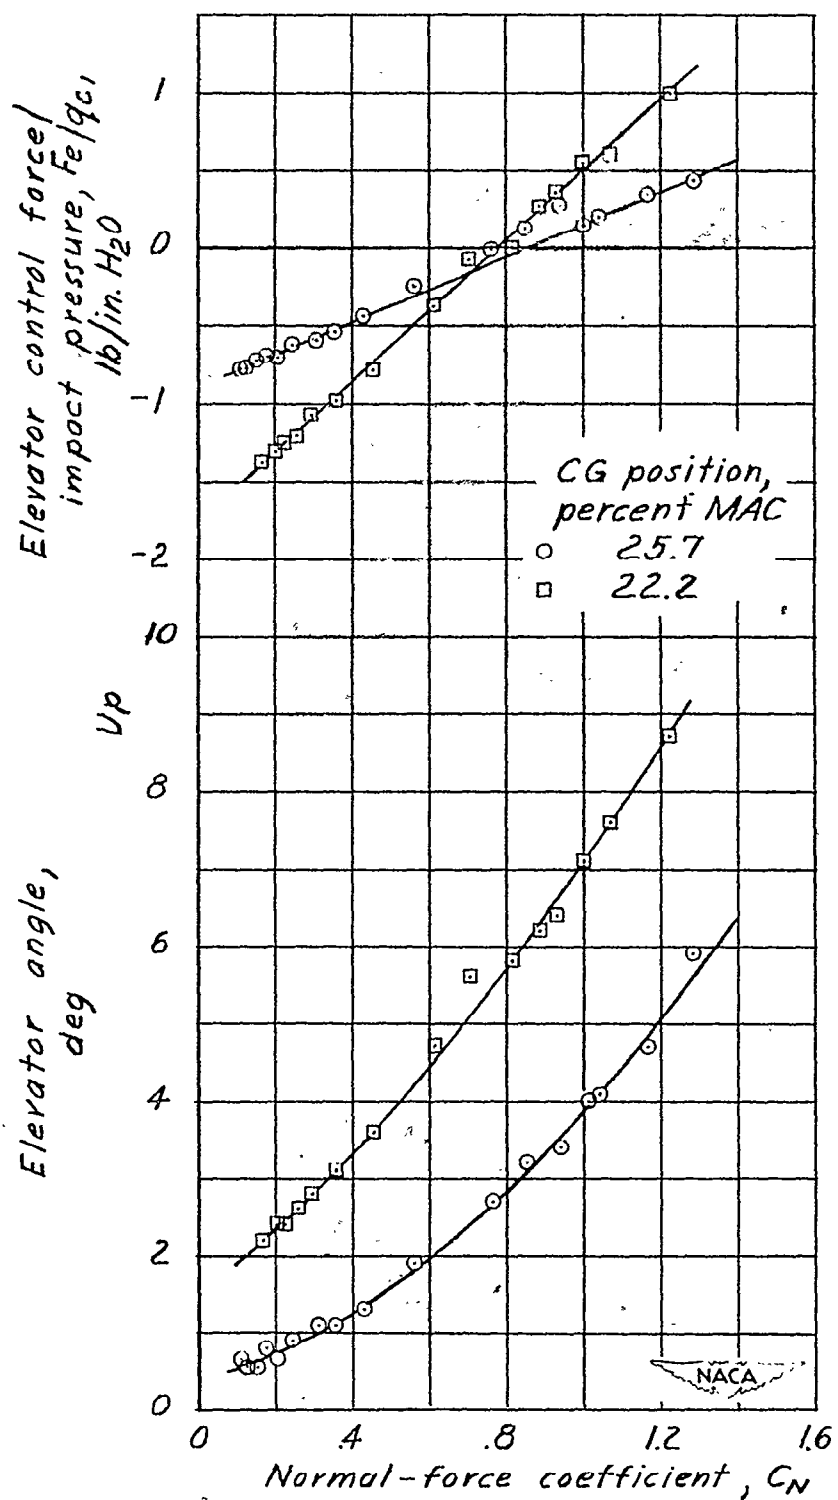
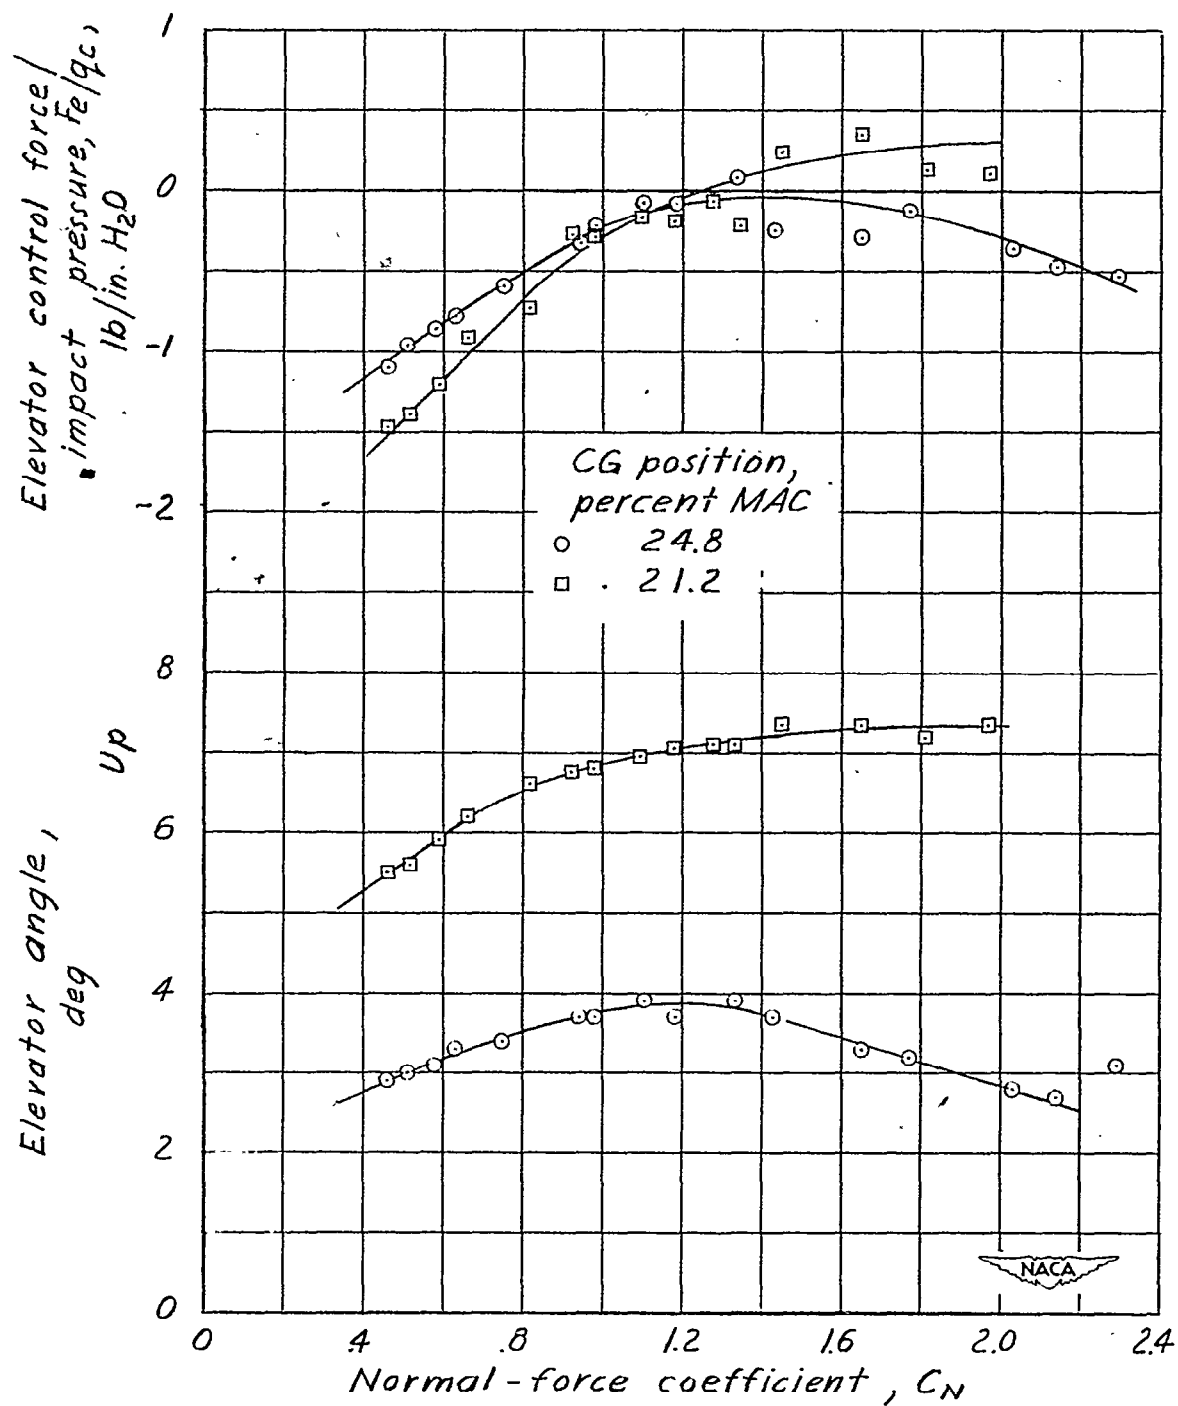
(a) Rated-power clean condition.

Figure 8.- Variation of elevator angle and elevator control force divided by impact pressure against normal-force coefficient. Grumman F8F-1 airplane.

(b) Gliding condition.

(c) Power approach condition.
